Tree Condition Survey 2018

Langley Park

Beckenham
Kent
BR3 3XU

Ref: MSURV/CV/2018/ Langley Park

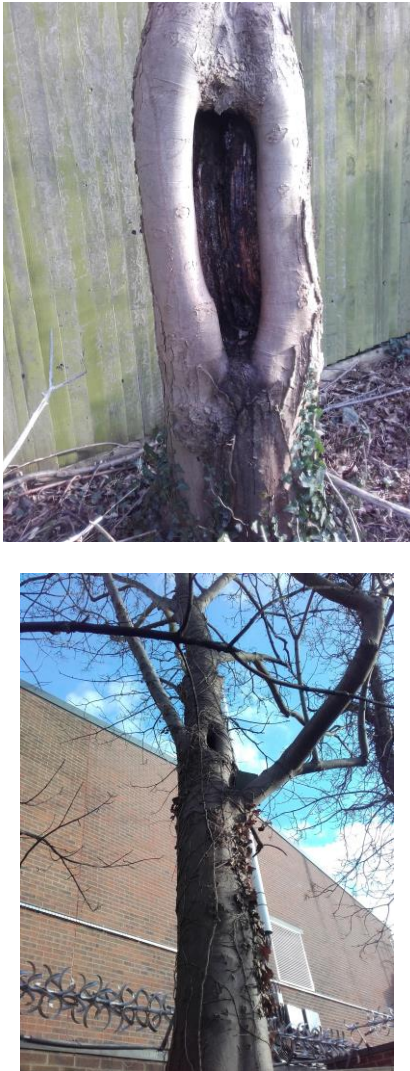
With regards of the structural condition of the trees at Langley Park it was noticed that some trees have had structural defects for a number of years in terms of stem cavities either at the base of the tree or further up the stem, further to this some trees were found to be dead. Some of these trees include T49 a semi-mature sycamore (see figure1 & 2) which has sustained a large stem wound which has evolved into a large cavity in addition the tree has a second cavity at approximately 8m also within the main stem. Although the tree is still safe at this time we should consider that the strength of the stem has been considerably reduced by the defects. T108 a mature horse chestnut looks in good health in terms of vitality when observed from the distance however, after a more in-depth investigation by removing the ivy around the stem the tree was found to be infected by *Phytophthora* or commonly known as bleeding canker which very often is related to *Aesculus hippocastanum* trees, in addition to the latter part of the lower stem is also decayed with visible signs of soft white rot which suggest a second fungal pathogen has also infected the stem. T98 a semi-mature lime has

<p>Figure 1 & 2: Showing T49 a semi-mature sycamore suffering from a large cavity within the lower stem and a secondary smaller cavity approximately 8m from ground level.</p>

been pollarded to 2m, the main stem is totally decayed and beginning to break apart (See figure 3). T518 a mature lime growing within the woodland area to the Northeast is infected with *Kretzschmaria deusta* a rather aggressive fungal infection often associated with lime trees. Its strategy is to initially colonise the roots system moving up the lower stem at later stage, the lime adjacent to T518 has already died possibly by the same fungal infection although no signs of fruiting body were visible during the inspection. All of the trees mentioned above have been listed to be removed on safety issues

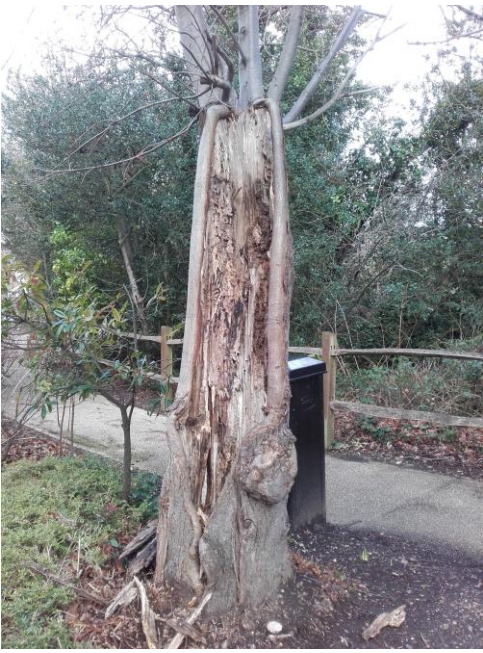
<p>Figure 3: Showing T98 a semi-mature lime with major stem defects, hollowing, decay and beginning to break apart.</p>

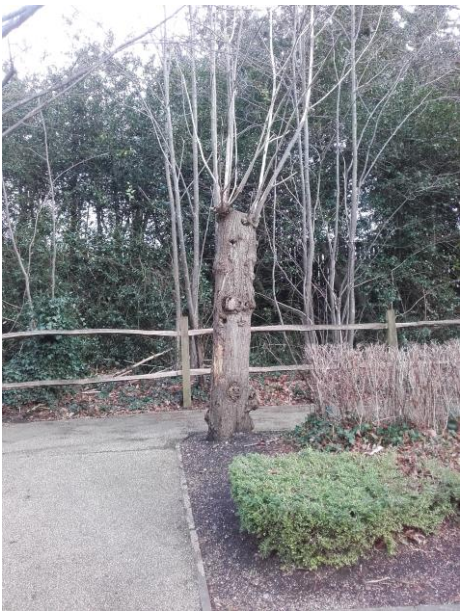
<p>Figure 4: Showing T100 close to T98, the tree is being dead for a year or so judging from the size of the re-growth compared with the remaining of the lime growing in the same area.</p>

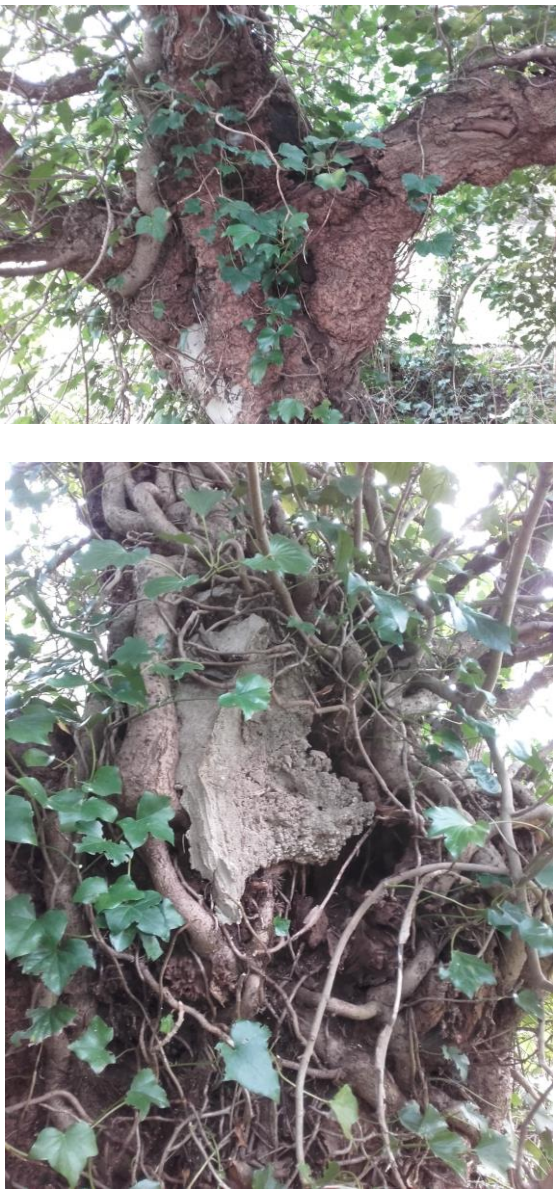
<p>Figure 5 & 6: Showing T325 a mature <i>Morus nigra</i>, the stem covered in ivy has two cavities which have been filled with cement. This practise of treating a tree cavity like a tooth has been abolished for number of years, this is because the cement prevents the tree from compartmentalise in other words to seat the cavity by producing new wood commonly known as “reaction wood”. This should be avoided at all cost within any trees in any circumstance.</p>

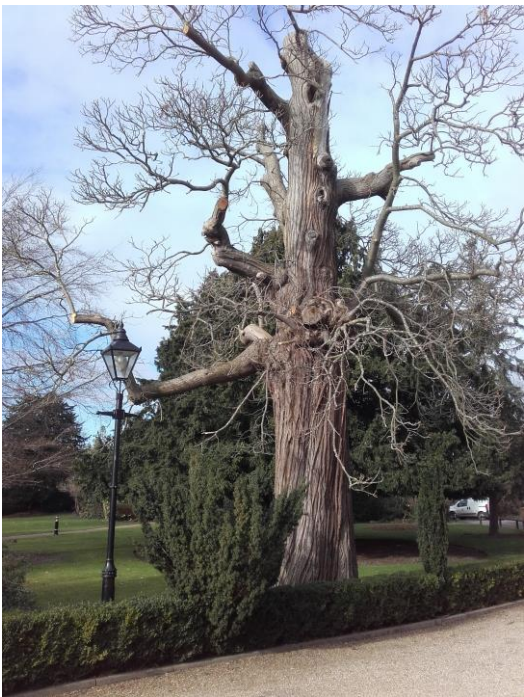
<p>Figure 7: Showing T330 an over-mature <i>Castanea sativa</i>, the tree has high value in terms of habitat within the cavities in upper stem and despite its current form of being dramatically reduced in height and spread this tree should be kept in the current form for as long as possible. Any removal of the upper stem should be backed up by a bat survey.</p>
